Changing Seals and Shims on a Pressure Regulator

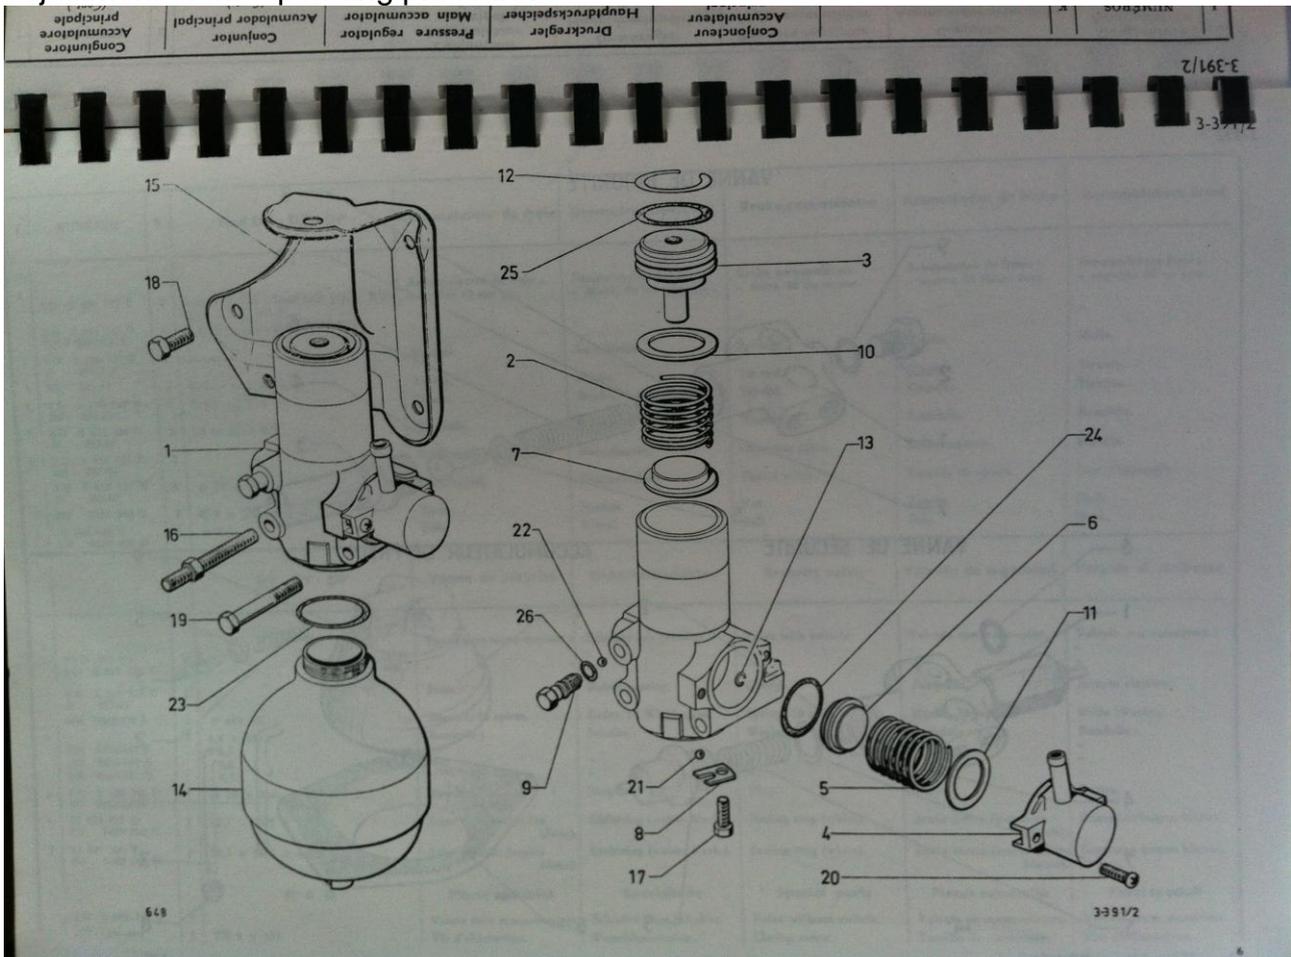
A pressure regulator that leaks LHM slowly (small patch on the ground after being parked overnight) can be the result of a leaking seal. I've never had this low pressure leak problem with older Citroens in all the years I've been driving them, but the dreaded slow drip has been there for a while now on my daily driver XM 2.5. This note sums up the replacement of two seals (items 24 and 25 in Fig. 1) which cured this problem and the adjustment of the operating pressure.

Pressure regulators on all LHM Citroens are virtually identical and operate on the same principle. They pass fluid from the hydraulic pump to all hydraulic circuits on the car at the correct pressure, returning the supply to the reservoir when the upper pressure limit is reached and then pressurising it again as soon as the pressure drops below the cut in pressure. The PR is supplied by a 6.35mm pipe from the hydraulic pump, a 4.5mm pipe then takes fluid at the correct pressure from to all circuits, and a rubber hose returns the fluid supply to the reservoir (when the pressure lies between the cut in and cut out values).

If you have a pressure gauge its worth removing the 4.5mm pipe from the PR and connecting a gauge to see what the cut in and out pressures are on the car. Shim washers (items 10 and 11 in Fig. 1) can easily be added to adjust the pressure limits upwards if necessary. Cut out is the max pressure (it should lie in the range 162-175 bar), cut in is the pressure at which the needle starts to rise again after opening the bleed screw (item 9) slightly (it should be 140-147 bar).

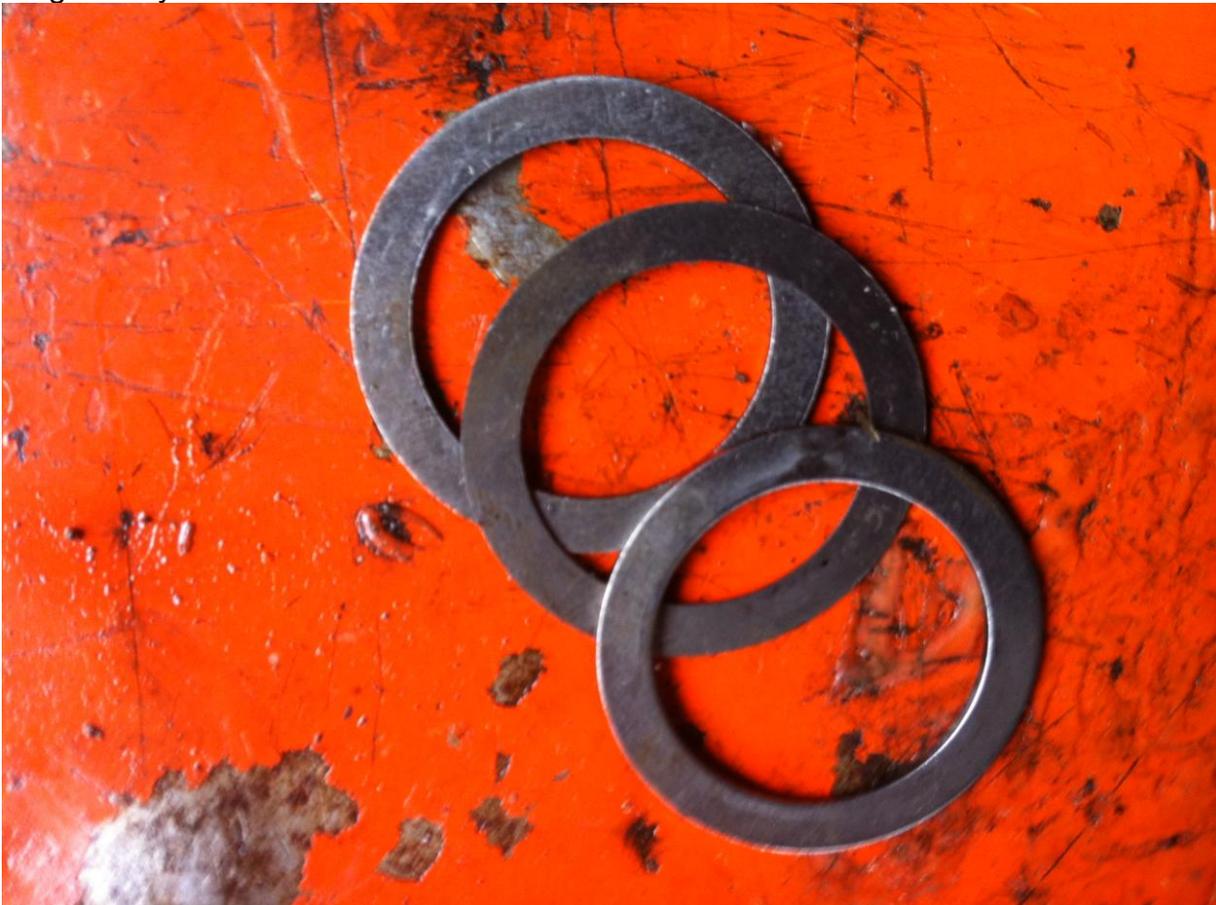
First take the side unit off, which connects to the return hose (item 4 in Photo 1: its plastic on XMs and Xantia, aluminium on older Citroens). This involves undoing two crosshead or Allen key M5 bolts gradually – it needs to be held on to stop the spring causing things to fly off as the bolts come away. At one end of the spring are shim washers and at the other is an O ring seal sitting in the PR body. If the pressure reading was low extra shims can be added. They seem to be in thicknesses of 0.3, 0.6 and 0.9mm; adding a 0.3mm thick one will increase the pressure by 2-3 bar so it's easy to get the pressure in the recommended range. They measure 28mm OD and 21mm ID.

The O ring measures 33.2 x 37.0 x 1.9mm (ID, OD, thickness). It may be possible to source some that are exactly this size, but if not a supplier can provide some that are dimensionally very close indeed. The new seal just needs to be placed where the old one was, the spring positioned, the shims added and the side unit cover placed over then put back in place. Again when doing up the two retaining bolts care is needed to stop the

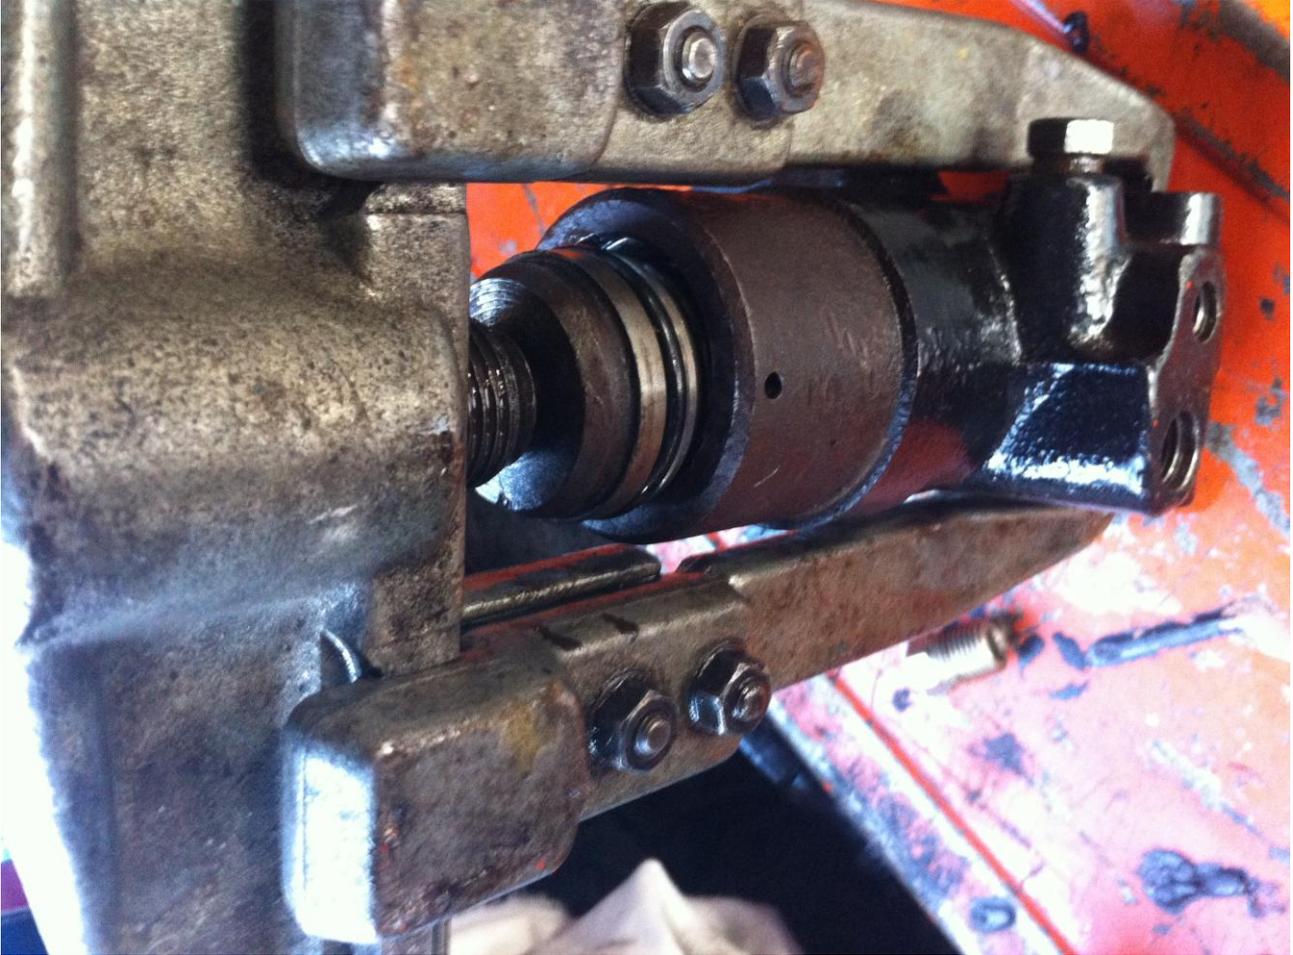
Second step is to remove the unit inside the end of the PR. This needs to be pressed in by several mm to enable a simple circlip to be removed. I use a big balljoint separator with a long central screw to depress the end against the spring force and reveal the circlip. Now if you're persistent the circlip can be removed with a couple of small screwdrivers and a hammer to get underneath it, but it can be fiddly and frustrating. An easier option is to drill a hole say 3-4mm in the side of the PR level with the circlip so that a small screwdriver or similar can be poked through it to push the circlip out. Once out, I unwound the screw of the balljoint separator and the spring pushes the assembly out.

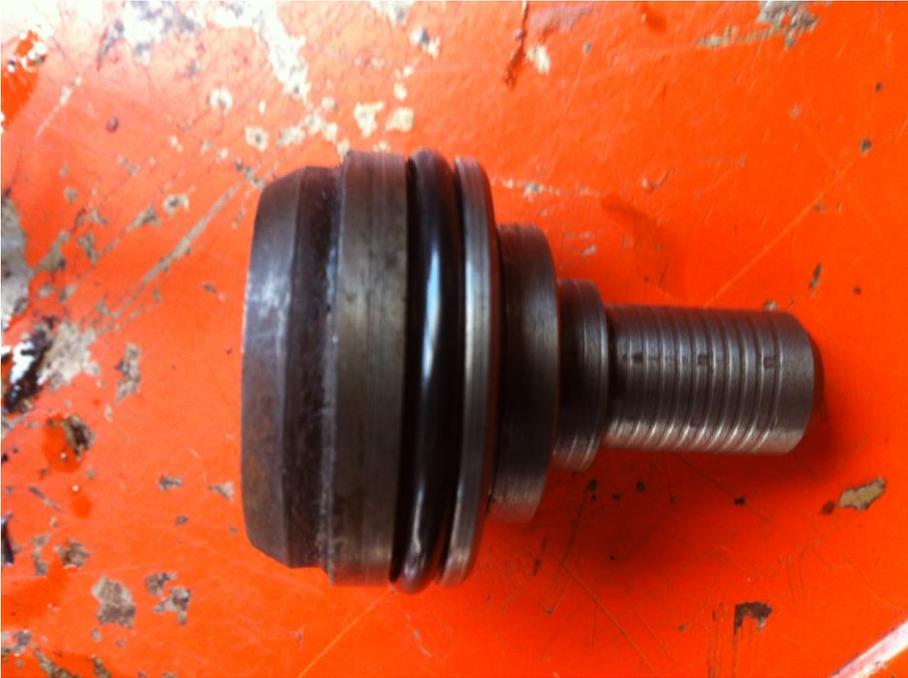
On the top of the spring is a thick end cap with a peripheral seal. The O ring is smaller and fatter than the other one - it measures 29 x 34.4 x 2.7mm. Between the end cap and the spring are washer shims - they measure 32mm OD and 24.5mm ID. Again the seal is easy to replace and the shims can be adjusted as before. Reassembly is the reverse process, just need to be careful to ensure the assembly enters the hole centrally as it's depressed, pop the circlip back in and release.

Changing the seals and shims is a 20 min job, getting the PR off and putting it back on the car can take a lot longer than that depending on which model it is! But this is an easy DIY job really and a good way to get the system pressure right. My XM is now cutting out at 172 bar and cutting in at 147 bar, which seems to me to have sharpened the brakes a little and smoothed the ride a shade too!
